# Damage Control

## Test Case

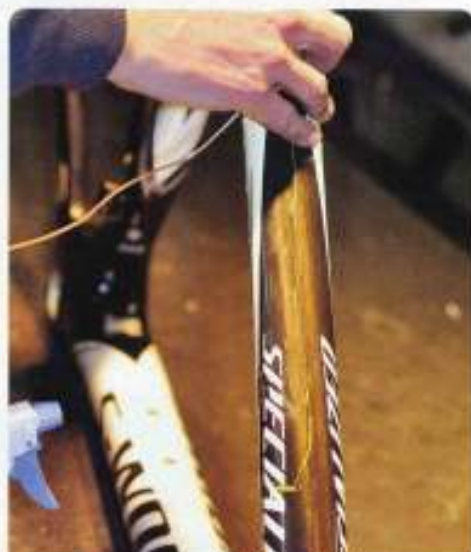
This road frame had obvious top tube damage from a handlebar impact. In this case, Raoul found delamination way back at the seat tube junction—it's unlikely that this would have been detected without ultrasound.

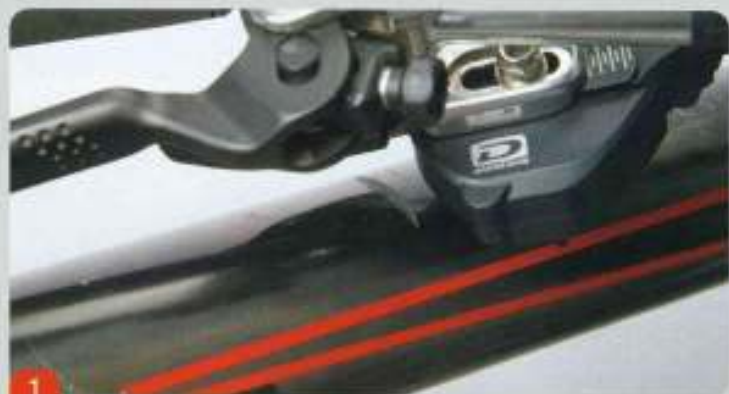
1

I damaged the frame when I crashed and the gear shifter pod slammed into the top tube. Normally I'd have the brake/shift lever tight enough to stay put but loose enough that they'll move in a crash before damaging the frame or breaking themselves. For whatever reason I'd done my levers up too tight and the head of a bolt on the shifter gouged the top tube. Over four years of general trail riding, my frame had copped plenty of general wear and tear, rock bashes on the down tube, chain-suck and so on. In this case, the depth of the gouge concerned me, as I know the Spark is such a lightweight frame; at 1,830g including the shock there can't be much wall thickness to the frame tubes. To start with I e-mailed a sharp close-up photo to Raoul and he suggested that it warranted inspection.

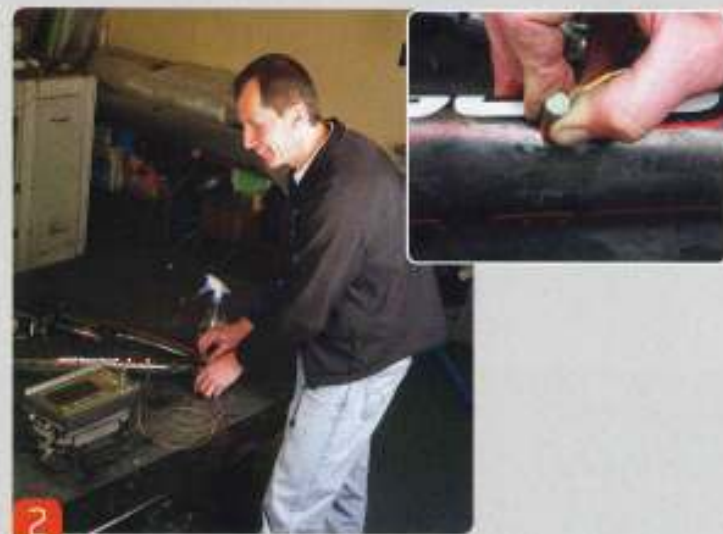
2

While the inspection technique varies depending on the part, ultrasound is probably the most common method used. Ultrasound lets Raoul gauge the wall thickness and assess the integrity of the carbon. Internal delamination, porosity, air bubbles and bonding issues will all show up as an 'indication' on the readout—if you know what you are looking at. Indications as small as 3mm or a single ply of damage in the layup can be detected—it is extremely sensitive.

The ultrasound revealed that the top tube on the Spark averages just 1.0 to 0.9mm thick and the gouge had gone through four plies of carbon. Each ply is approximately 0.1 to 0.13mm thick, so the damage had compromised close to 0.5mm of the carbon—that's around half the wall thickness on the Spark and definitely something to worry about. Raoul also checked right over the frame, looking for any other damage. He didn't find structural issues in other areas, so the frame was well worth repairing.

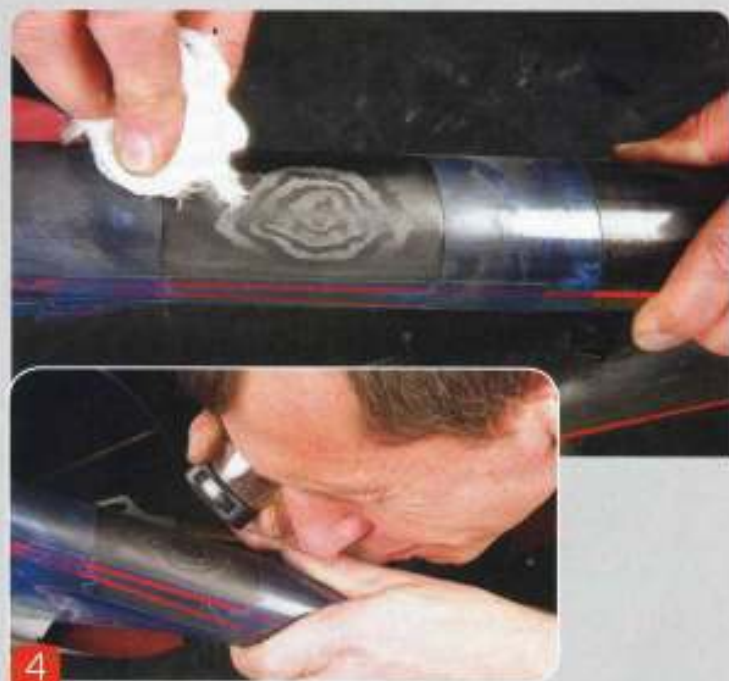
4

After a wipe over with a solvent to remove any residue, you get a much clearer picture of the frame construction. It's now easy to see all the different layers or plies of carbon that make up the frame tube. Raoul now gets in close with a magnifying glass and notes the number of plies, as well as the orientation of the fibres in each ply. Unidirectional carbon forms the structural heart on most carbon bikes and the direction that the fibres travel in determines the performance characteristics of each part of the frame. Diagonal placement of the fibres provides more torsional stiffness while linear placement limits longitudinal stretch. Taking note of the fibre orientation means the patch can be matched to produce the same performance characteristics as the original frame material. In addition to retaining the same ride quality, matching the strength and stiffness ensures the patch doesn't place undue stress on the surrounding material.
