# Damage Control

## Test Case

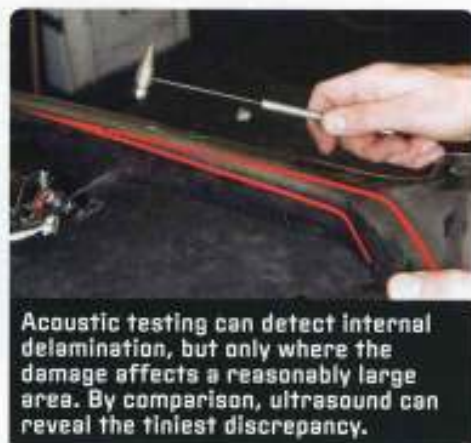
Acoustic testing can detect internal delamination, but only where the damage affects a reasonably large area. By comparison, ultrasound can reveal the tiniest discrepancy.
